Navajo Abandoned Uranium Mine Site Screen Report

Bibo Trespass AUM Site

Navajo AUM Eastern Region

May 2009

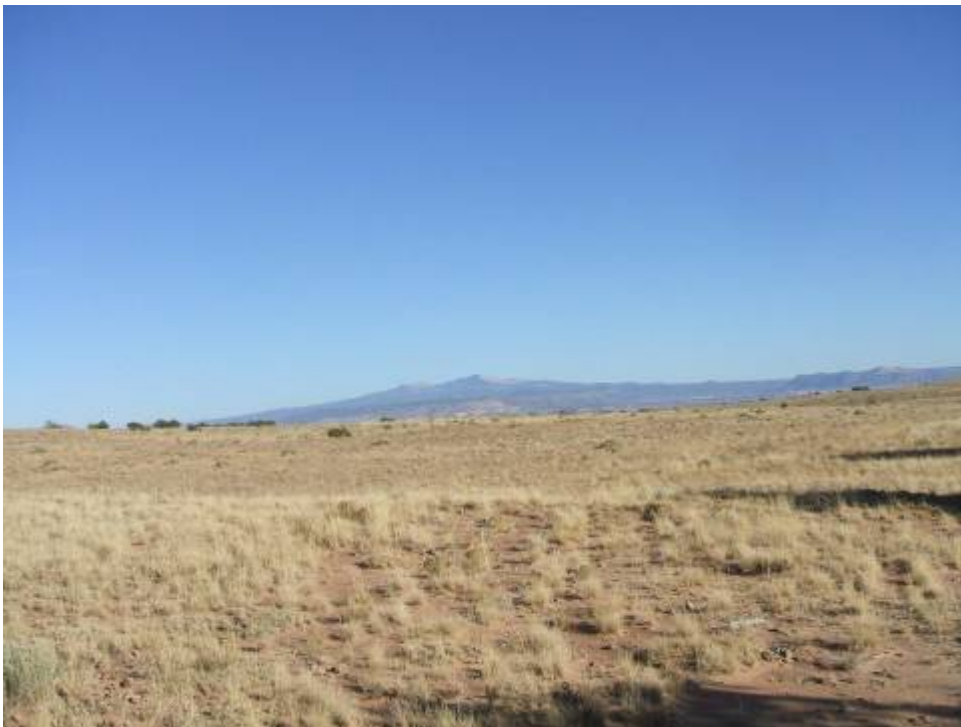
Photo 2. Bibo Trespass mine site, towards the east

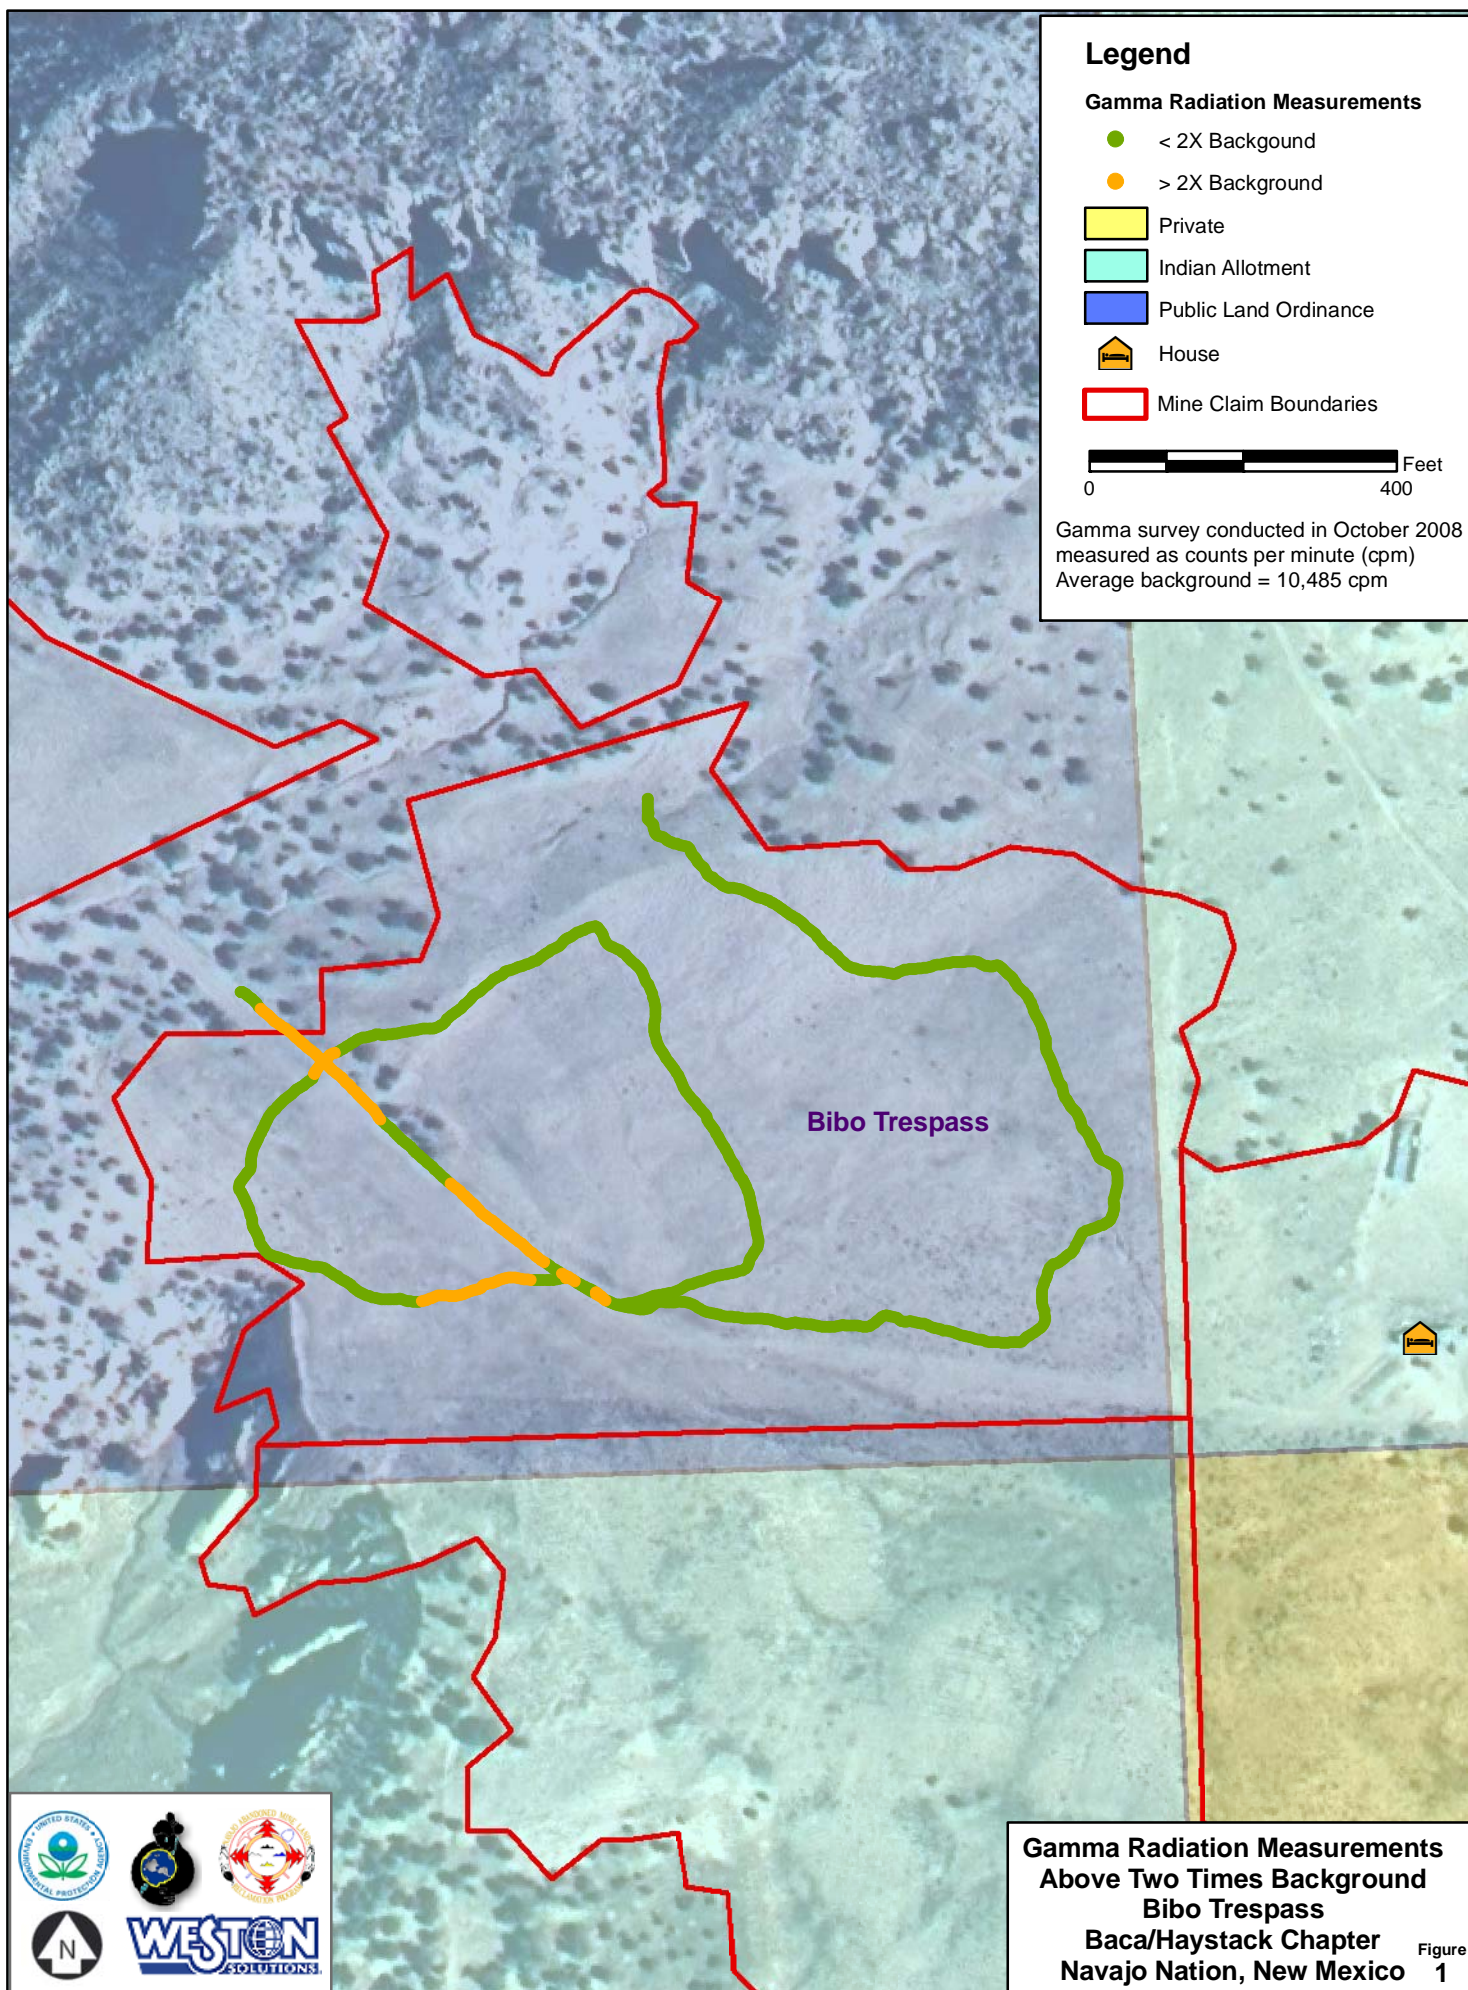
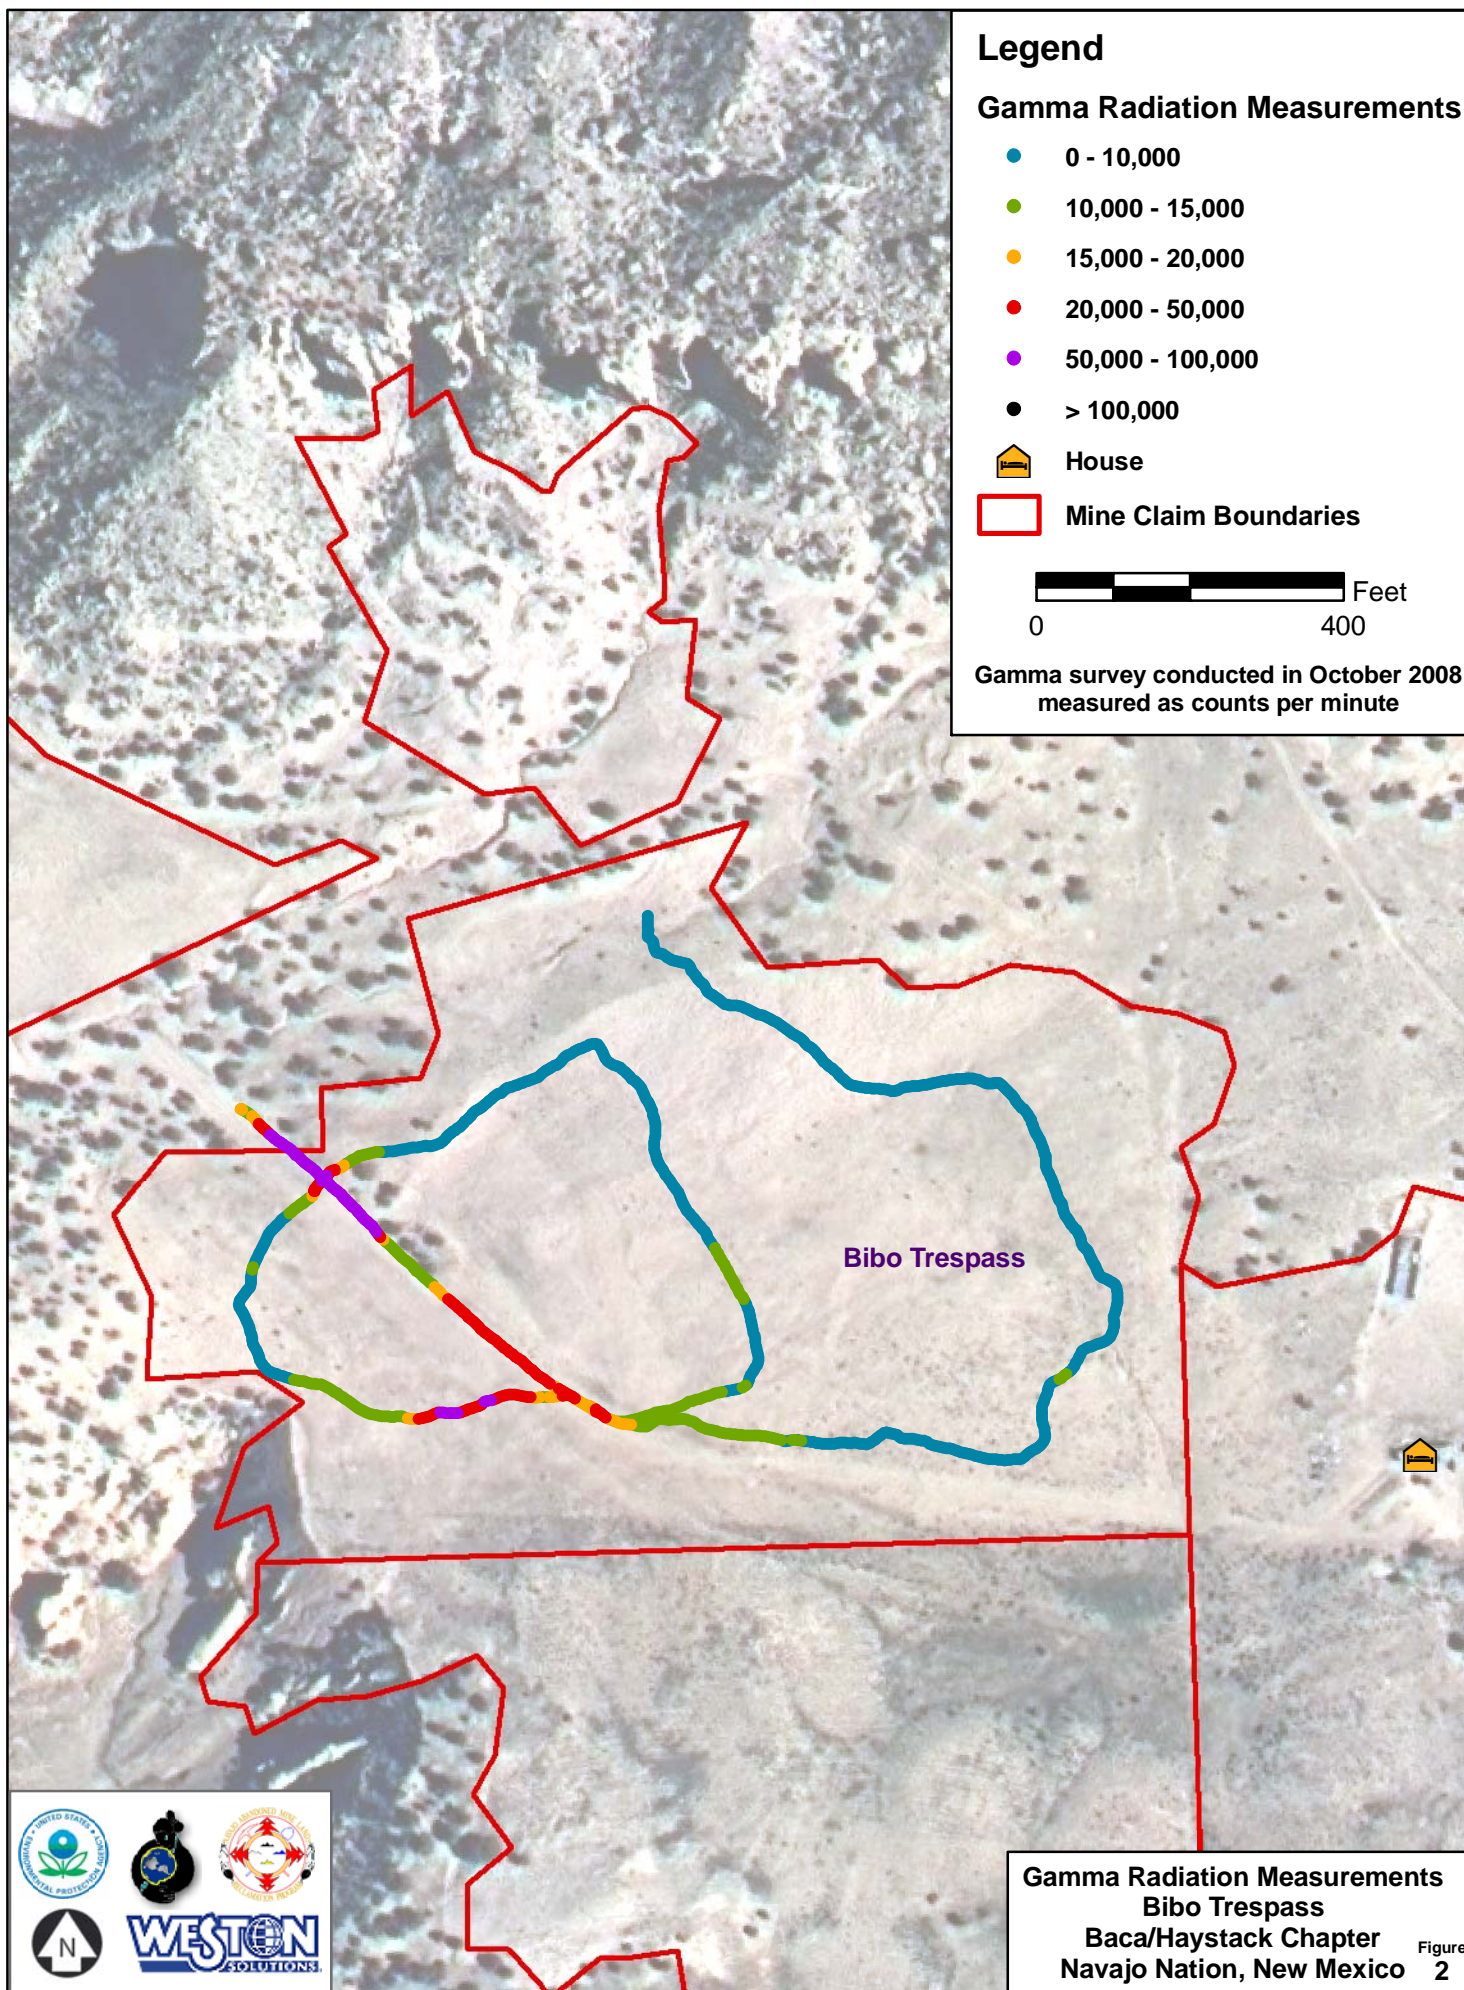
1,095 gamma radiation measurements were collected from mine sites, ranging from 6,552 cpm to 89,750 cpm. Measurements were found at their highest along the dirt road transecting the site. The measurements are represented in Figures 1 and 2.
